## CENTRAL INTELLIGENCE AGENCY

SUBJECT Naval Vessels and Port Facilities in Ventspils DATE DISTR. 16 September 1957

Attachment A: A seven-page general report covering naval vessels observed, radar and radio installations, shipyard facilities, harbor installations, and economic information. This report is accompanied by a port plan and legend indicating 65 features observed in Ventspils, [REDACTED] 25X1

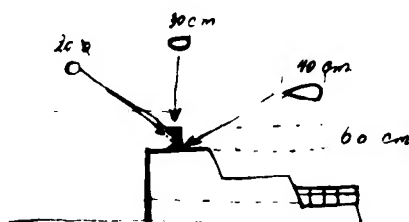
sheet 3

a. Conning tower (point 1).

Height was approximately 4 meters, length twice the height, double bayonet-shaped; a railing (point 2) was located on the lower bayonet-shaped part.

The conning tower was closed at the top (point 3) by a lid, which could be removed. This was clearly noticeable by the dividing line above the portholes (point 4).

A water-deflector (point 5) was located half way up the conning tower. A direction finder (point 6) was located in front of the conning tower.

About 8 meters from the bow, a manhole cover (point 12), 50 centimeters in diameter, was seen in open position. A telephone buoy (point 13) was located about 12 meters from the bow.

An exhaust (point 15), also 20 centimeters in diameter, was located immediately behind the <sup>con</sup>ning tower, and reached into the water. The length of the hull was about 40 meters. The distance from the conning tower to bow, was approximately 20 meters, and the distance from the conning tower to stern, was approximately 12 meters.

2. At starboard and port side of the bow, two torpedo tubes (point 11), each about 2 meters in length and about 45 centimeters in diameter, were located at about 20 centimeters above water level.
